The Old Coach Road (U3132 & U2236)

Survey: February 2018

Completed by: S.Stout – Cumbria Trail Riders Fellowship (CTRF)

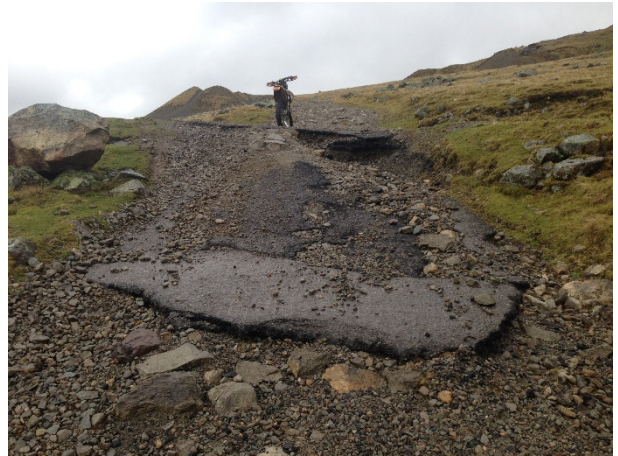
Picture 1:

Washed out area below tarmac link road between quarries. Old tarmac visible. (Possible stone pitched area as plenty of stone nearby). This section is 2.5m wide at it's lower end and 4.5m wide at the tarmac junction.

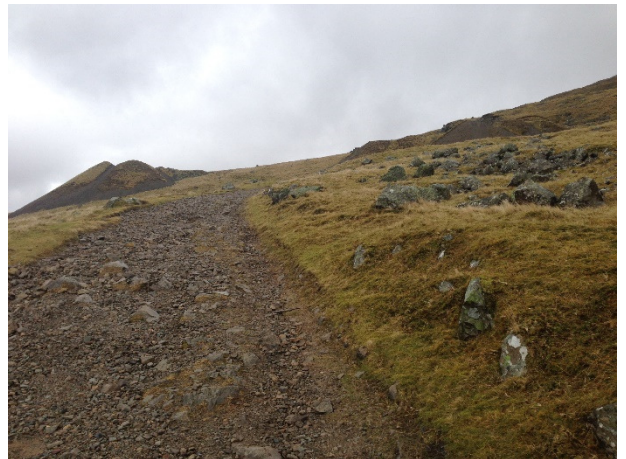
Picture 2:

Steep climb to quarries, surface is good and requires no real work. No water damage visible currently.

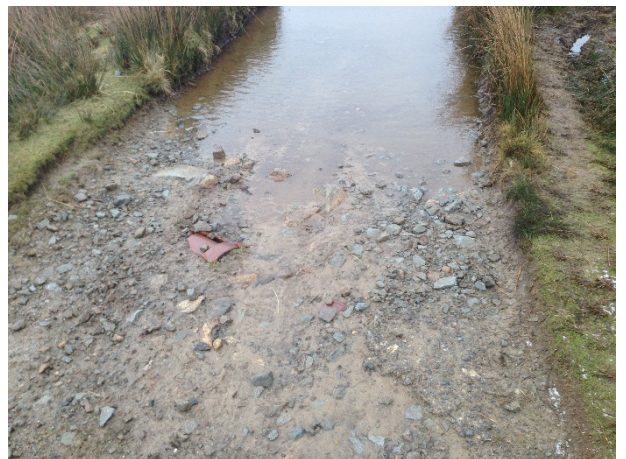
Picture 3: Puddle 1.

Drainage line from Clough Head. Long catchment channel blocked on uphill side allowing water to escape onto road surface. Clay pipe culvert, now broken and both entrance and exit overgrown. Cleared manually to restore flow and opened drainage line onto downhill side of puddle

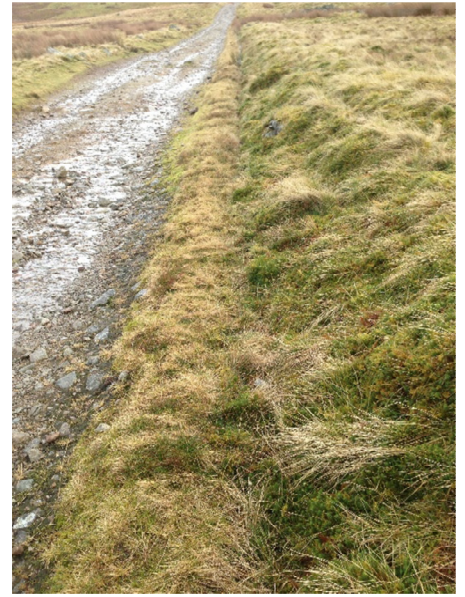
Picture 4: Overgrown drainage channel, very narrow and almost disappeared. Minimal work required here.

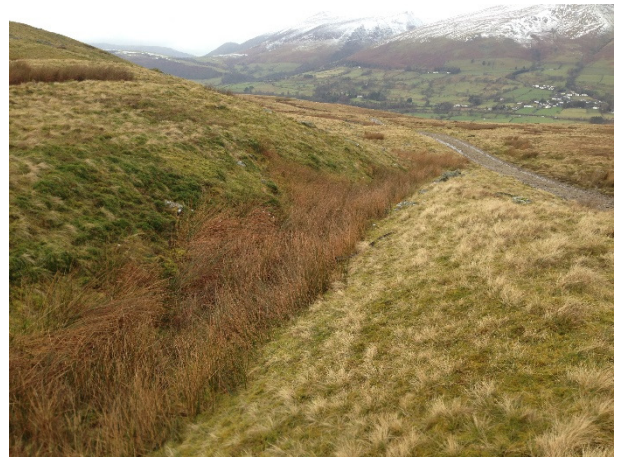
Picture 5: Manmade drainage line, possibly linked to old ruins nearby.

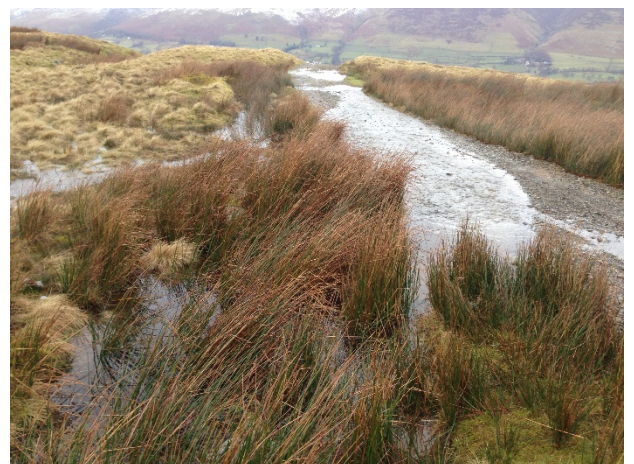
Picture 6:

Hausewell Spring is situated at the top of Hausewell Brow and is a water source for houses and a farm lower down the hillside. The water pipe runs under the road surface from the spring. (Position to be identified). Running east to west there is an overflow drainage channel from the spring to Birkett Beck. (see picture 6)

Hausewell Spring channel. This should follow a channel along the edge of the road surface heading west, then pass through two culverts under the road to the north and drain into Birkett Beck level with the house 'Newsham'.

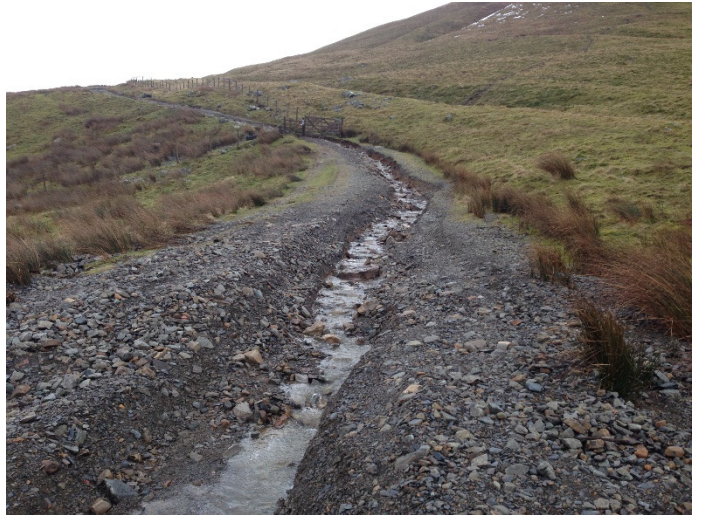
Picture 7:

Clough Fold, bottom of water damage channel leading up to Hausewell Brow. This has flowed out on to the lower peat slopes leaving lots of fluvial waste covering the ground adjacent to the road.

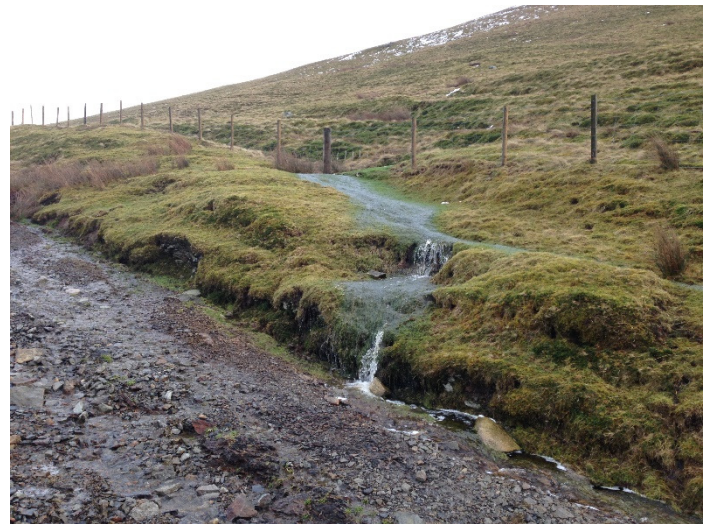
Picture 8:

Heavy runoff after rainfall from White Pike & Hausewell Spring. This drops into the drainage gully above the culvert.

There is a drainage gully for the spring that is also choked and requires clearing running above the fence line.

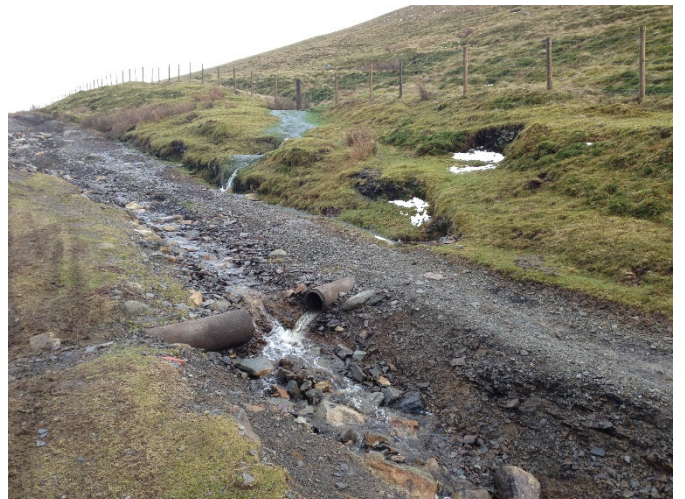
Picture 9:

Damaged culvert below run off allows water to erode the road surface. This requires a full replacement with the culvert extended approx. 2 m past it's current finish to allow water to flow to the moorland below.

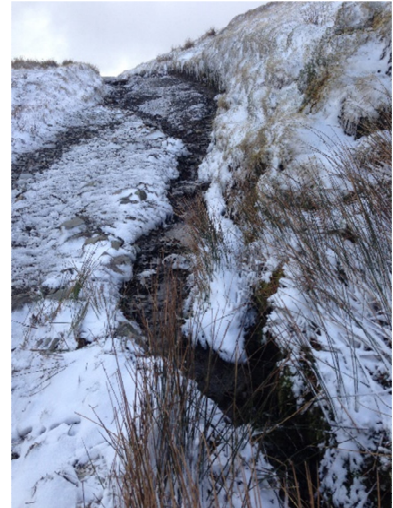
Picture 10:

Test works carried out on Hausewell Brow clearing the main drainage gully have shown a marked impact upon the water levels running along the lane surface.

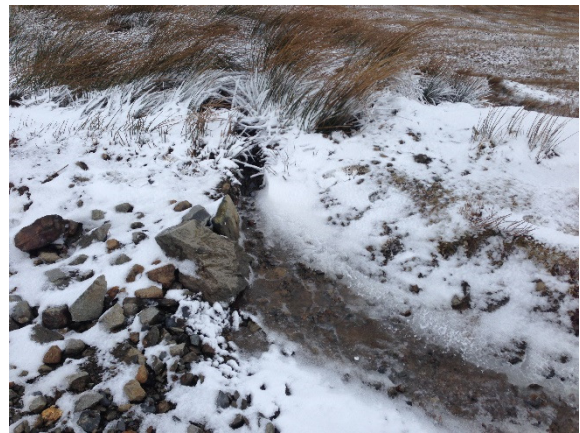
Picture 11:

Test works – Where water has seeped past the temporary remedial works, surface drains have been built to change the water flow direction. This shows marked impact on the lower sections of the road surface.

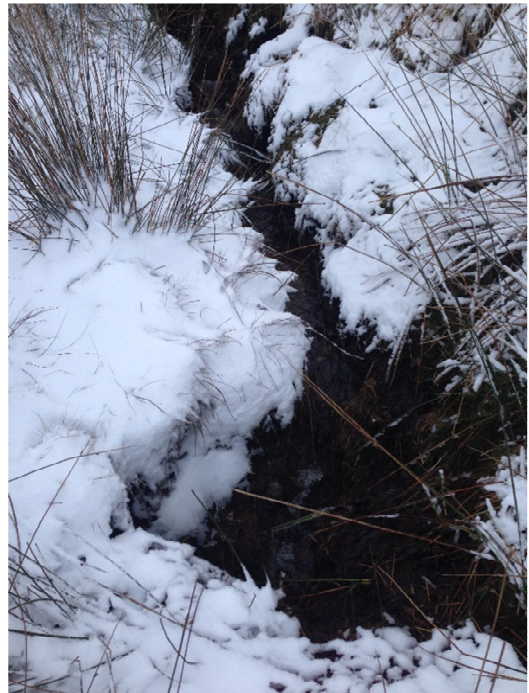
Picture 12:

Test works. One of two culverts cleared and water flow restored using hand tools only. This also showed a positive impact upon the water flow to lower sections of the road.

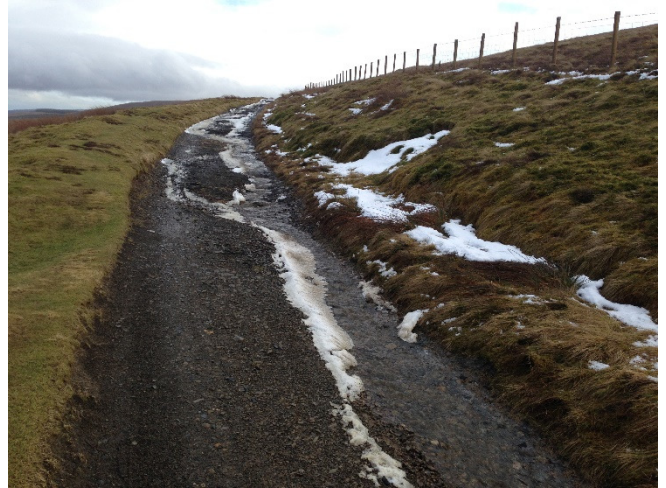
Picture 13:

Final approach to Hausewell Brow from the western side. A collection of water channels lie on the road surface and no drainage is obvious.

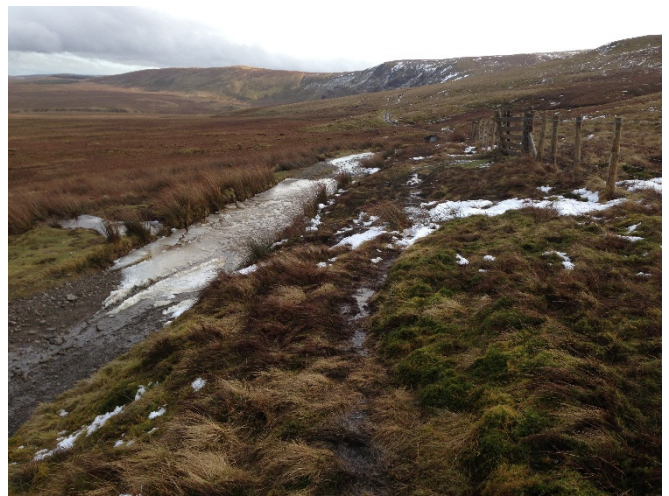
Picture 14:

Top of Hausewell Brow. Snow and water collects in eroded road surface, drainage insufficient as road surface now lower than existing channel. Manually opened out to allow excess water to flow downhill. (Showed a drop-in depth over twenty-four hours even with heavy rain).

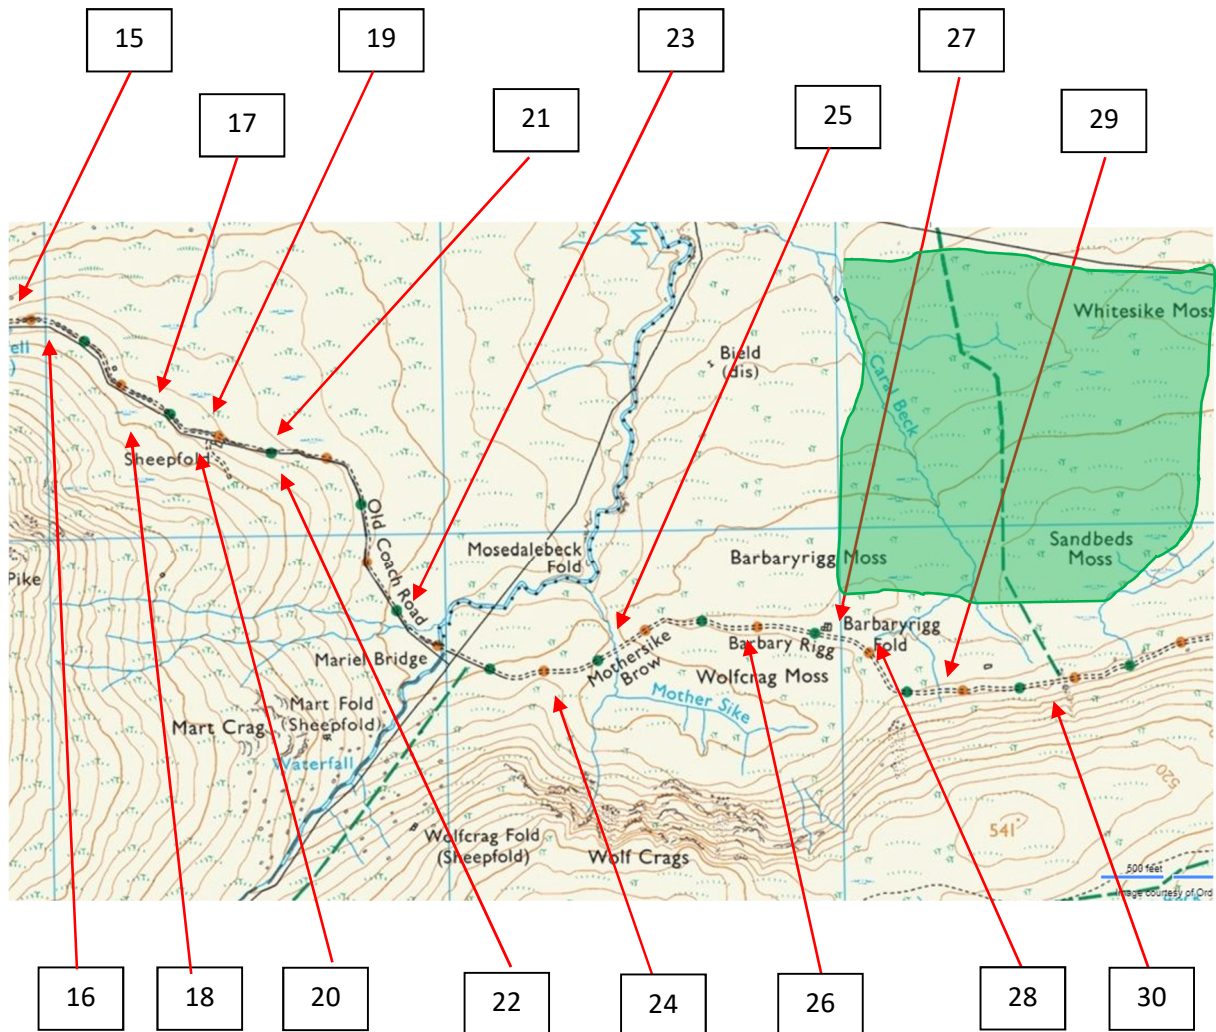
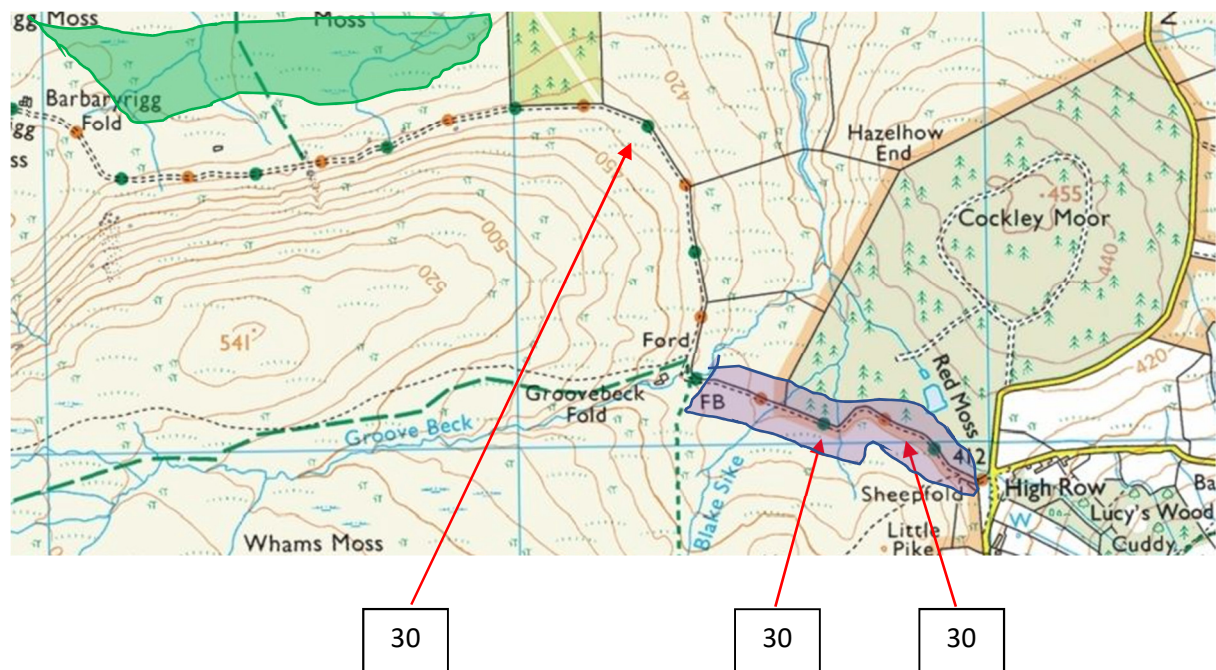
The NT are currently carrying out a Peat Regeneration Project between Threlkeld Common and Cockley Moor Woodland using heavy machinery, they have accessed their work site via the Coach Road and there is evidence of their passing visible along this section of the road from Lucy's Wood. (On the map image 1 below, this area is shaded green and is estimated in size based upon the works visible on the ground)

On map image 2, the January 2018 CTRF volunteer work party area is shaded in purple. This shows a much drier road surface after nearly a month since the works were completed. The cleared culverts are flowing well. One culvert has been broken in the last week and the road surface has been damaged and now requires remedial works.

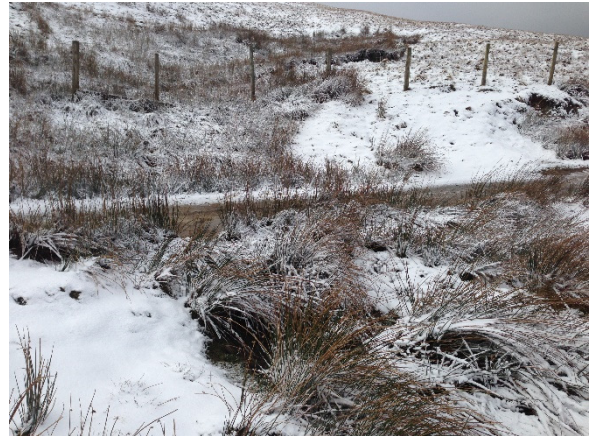
Picture 15:

Overgrown and blocked culvert creating overflow on to road surface.

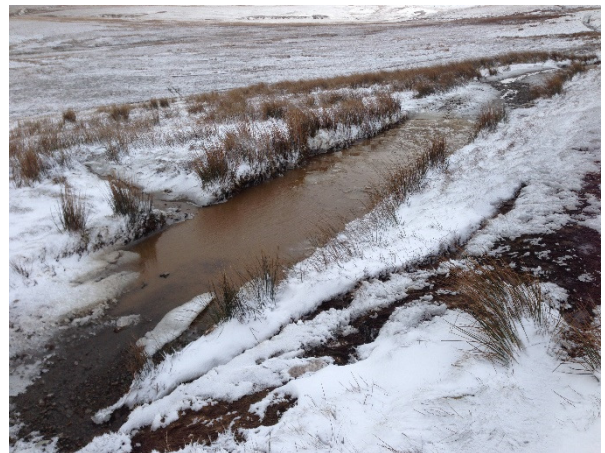
Picture 16:

Road surface eroded below current drainage channel. (opened out in test phase but required heavier tools to complete).

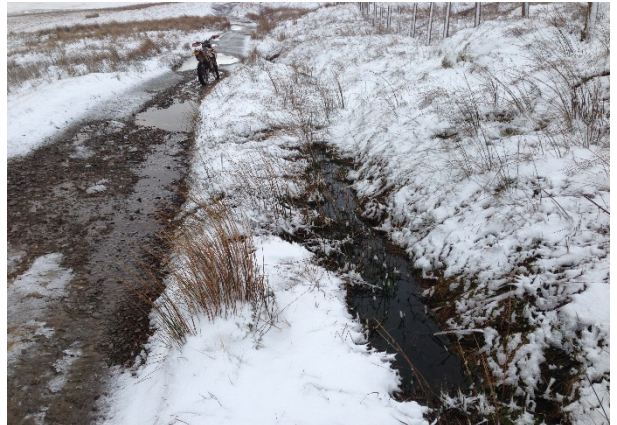
Picture 17:

Blocked drainage gully over spilling side walls

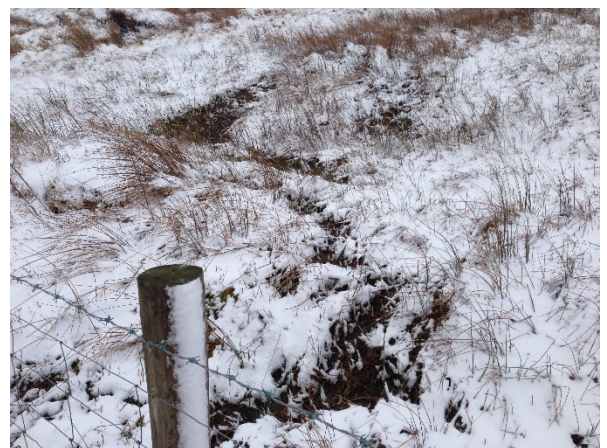
Picture 18:

Hillside drainage on to road surface as upper drainage channels are also choked.

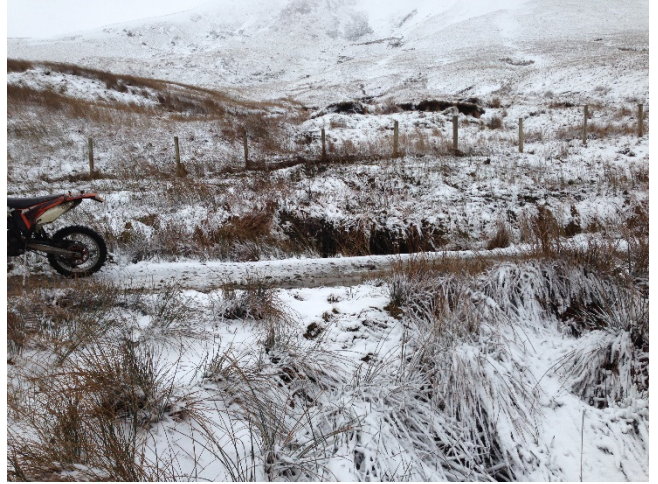
Picture 19:

Culvert still running, but water overflowing on to road suggesting a blockage. This is a large drainage area from the fellside above feeding in to a bowl and then exiting via the culvert.

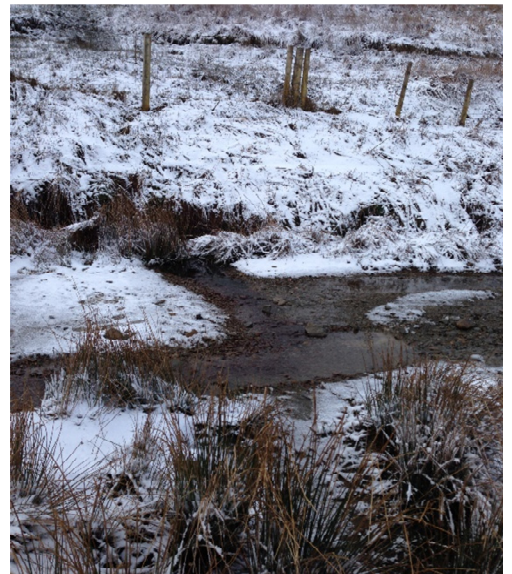
Picture 20:

Culvert still running, but water overflowing on to road suggesting a blockage.

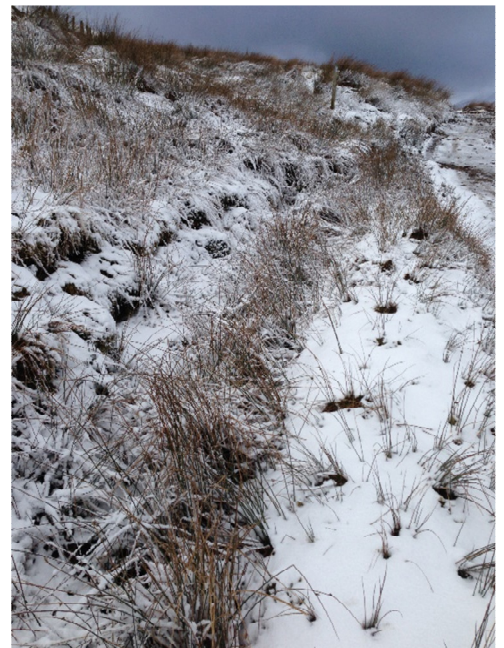
Picture 21:

Drainage gully virtually disappeared leading to issues identified in Picture 22.

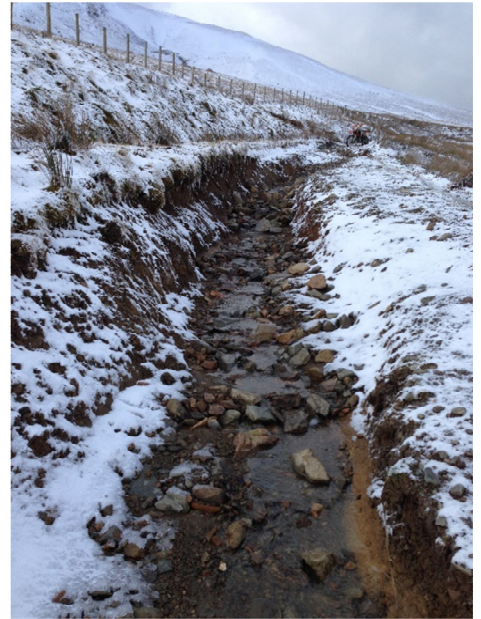
Picture 22:

Water eroded trough. The drainage gully is on the left bank of this picture and is completely blocked at this point allowing the water to run over and onto the road surface.

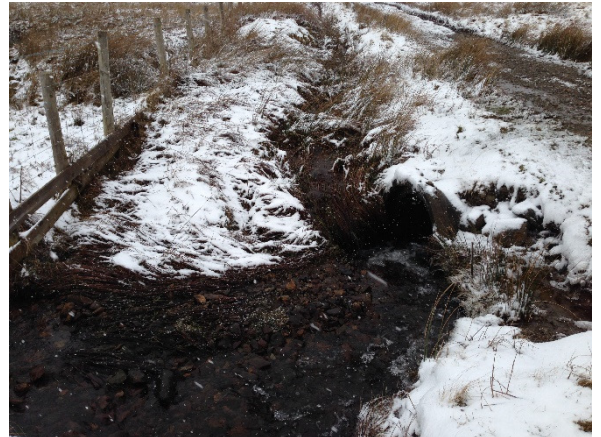
Picture 23:

A secondary beck runs off the fells from White Pike and above Mosedale Beck. This is the culvert that runs under the road at this point. The road gully above is choked as per the rest of the gully.

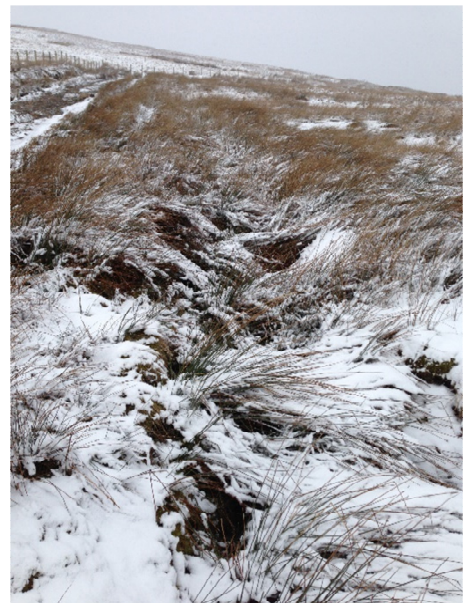
Picture 24:

On the northern side of the lane there is a secondary drainage channel running east/west. This is also choked with moss and soft grass. A culvert may run under the lane at this point. It is unclear in current conditions.

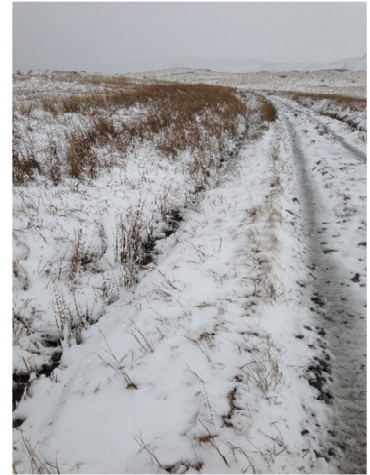
Picture 24:

Between Mariel Bridge and Mothersike Brow, there are two drainage gullies, one on either side of the road. Both are deeper than the western ones and thus require less remedial work. However, both are becoming choked and in one steeper section, the gully walls have broken and water is now flowing on to the road surface. The road surface here requires some maintenance to repair damage to soft sections. (see red circle in picture 25)

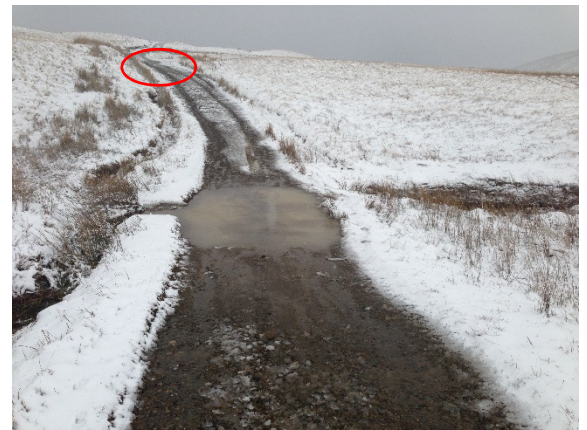
Picture 25:

Water is collecting at the bridge at the bottom of Mothersike Brow. The drainage in this section needs looking at when conditions allow.

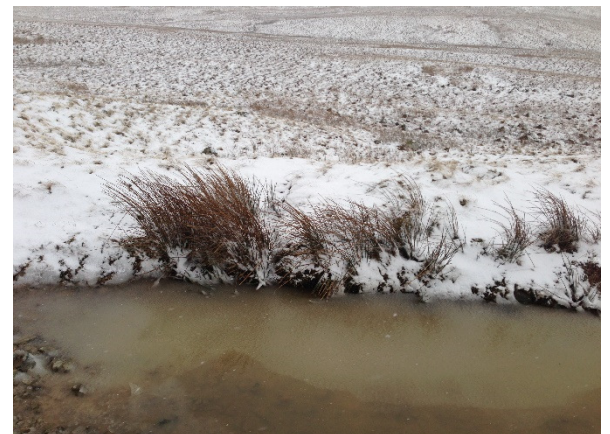
Picture 26:

Surface drainage – the road surface has been eroded away leaving the drainage exit point higher than the water levels.

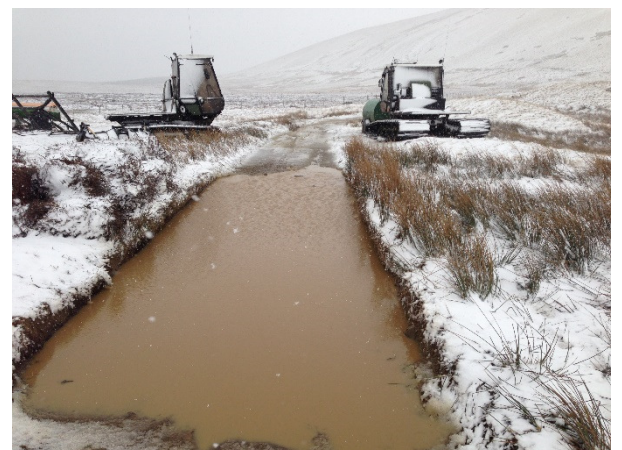
Picture 27:

The NT are currently carrying out a Peat Regeneration Project on Matterdale Common between Mosedale Beck and Thorngill Beck. The heavy machinery has used the Coach Road for access and evidence of their passing is visible along the section of the road. (See Eastern Section picture 27)

Surface drainage - NT machinery has 'squared off' the edges of the larger puddles and made them noticeably deeper. The drainage here is suffering from the same issues of eroded road surface leaving the drain exit above the current water levels.

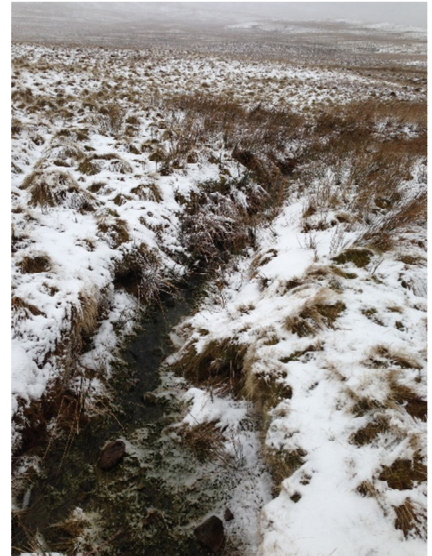
Picture 28:

At GR NY 366 222, the drainage on the uphill side has two channels, one dug west and into the moorland with presumed drainage into Wolfcrag Moss, the other runs along the edge of the lane nw/se for approx. 100m to a dead end. This may hold a culvert, to be determined in better conditions.

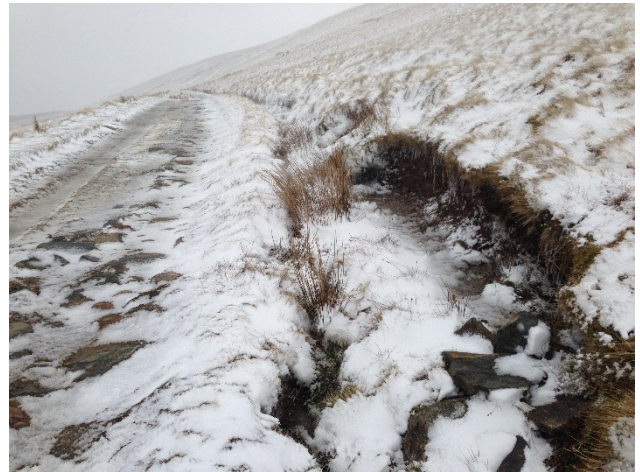
Picture 29:

Between GR NY 366 222 and NY 372 224 the drainage channel is choked. The road surface is generally in good repair with some large puddles of standing water. One in particular is approx. 1m deep. This has caused problems for the local farmers accessing their livestock and needs remedial works asap. The culverts are all running but need some clearances

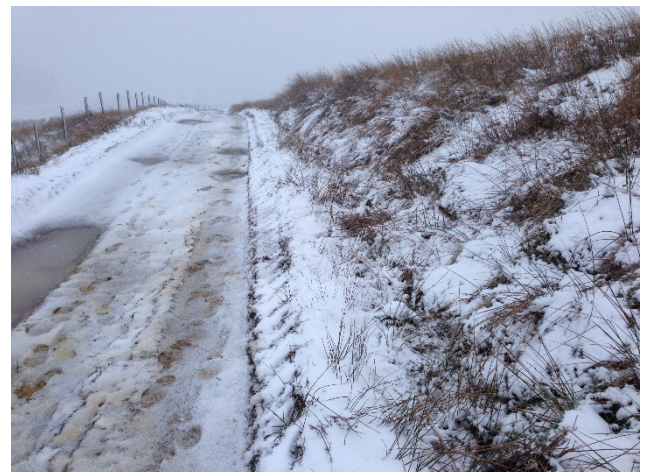
Picture 30:

Drainage choked, road surface condition acceptable.

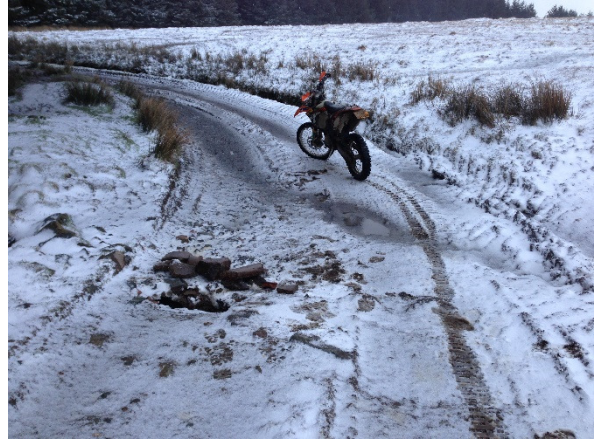
Picture 31:

Broken concrete culvert at GR 371 221. This has collapsed in on itself, possibly due to heavy vehicles passing over it recently. The culvert was cleared by CTRF in January 2018 and is running well but needs immediate remedial work.

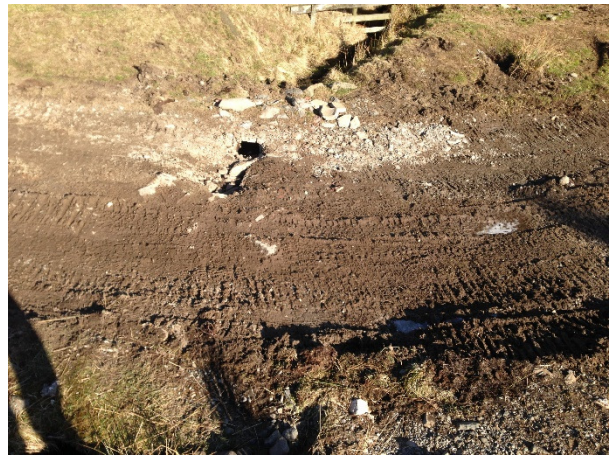
Picture 32:

This photo is a week after the initial survey, the damage is greater and the culvert is now blocked by debris from the road surface and parts of the broken culvert body. Cumbria Wildlife Trust are to repair and replace this culvert at the end of their Peat Restoration Project. As of 30/04/18 this repair has not been completed.

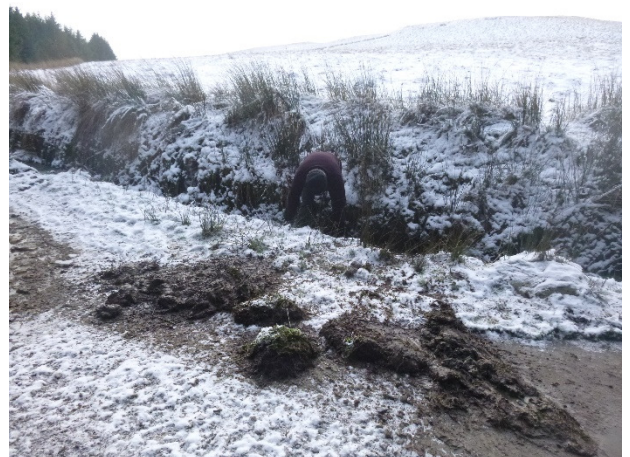
Picture 33:

Repair day image. Gully clearing between Grove Beck and Lucy's Wood. This area is largely dry now with little water retained on the road surface. From the gate at Lucy's Wood for approx. 200m some surface water is still there as the surface of the road is below the drainage exit points.
