The Old Coach Road (U3132 & U2236)

Survey: February 2018

Completed by: S.Stout – Cumbria Trail Riders Fellowship (CTRF)

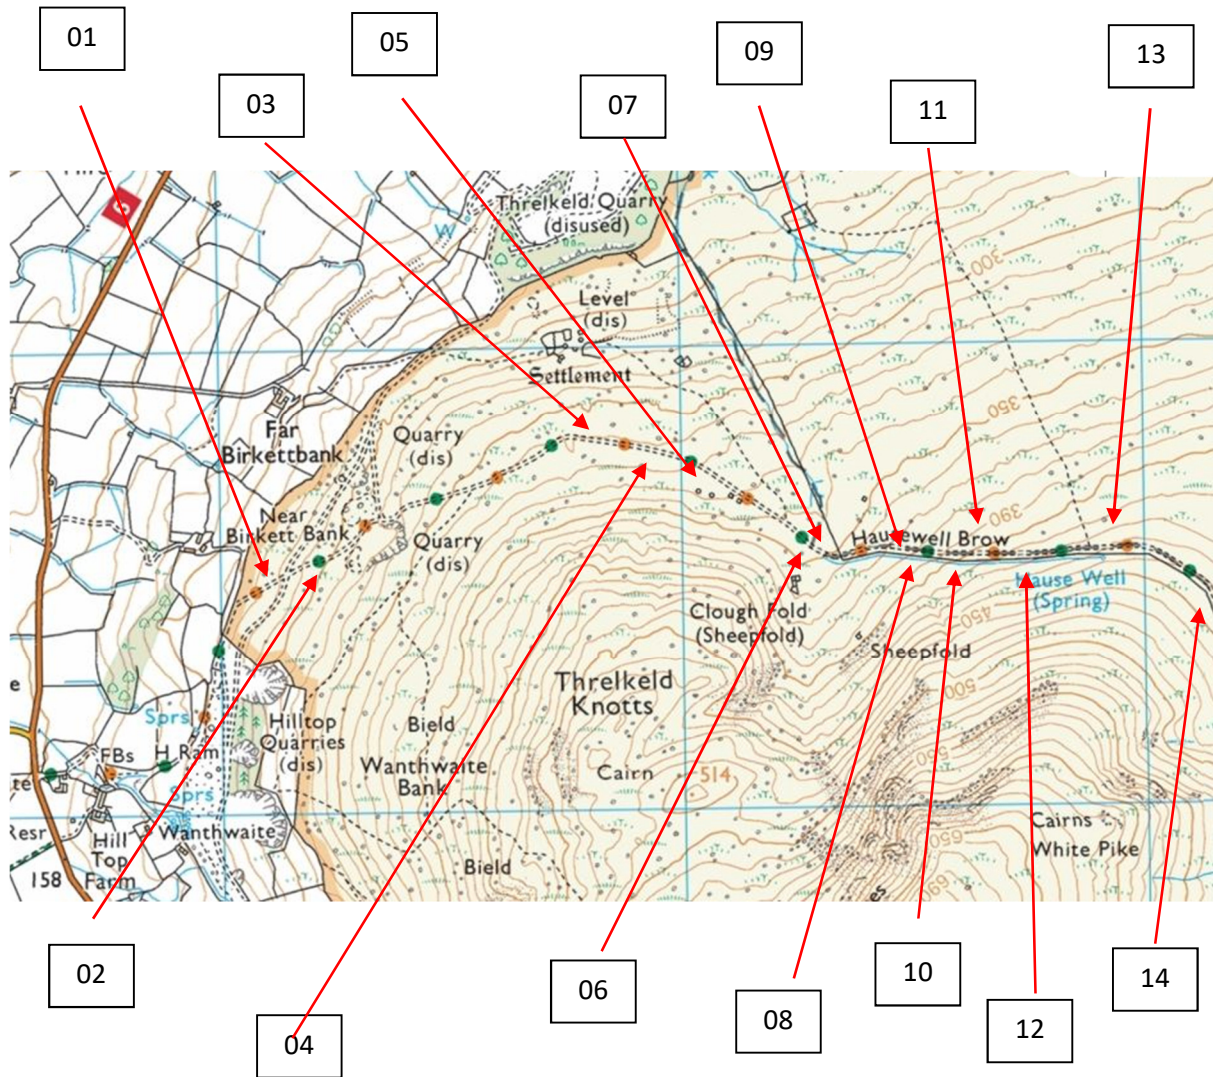
The map below shows the western section and references the information for each picture. The eastern section has its own part.
